SA17-08, July 2017

## Lack of pillar support - underground opal mines

This safety alert provides information on a serious safety issue and safety advice for the NSW mining industry.

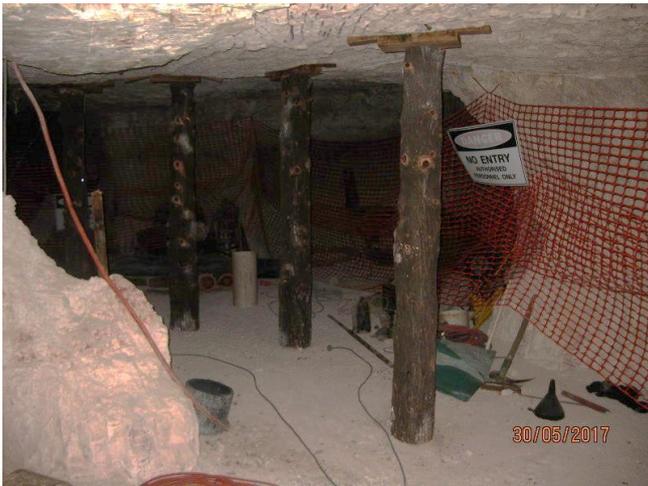
Figure 1: Some secondary support included.

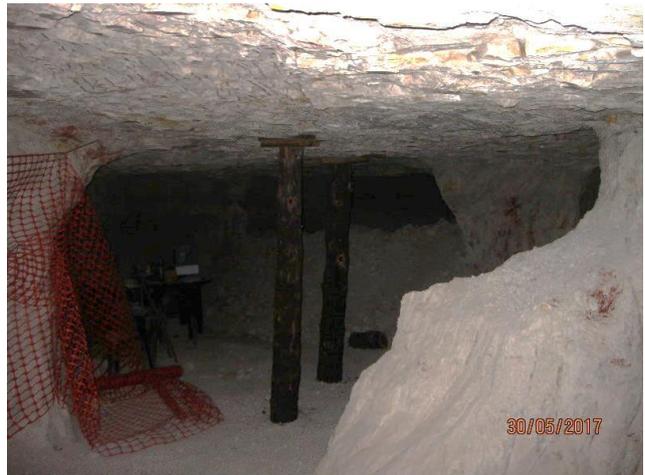
Figure 2: Combination of minimal secondary support and reduced primary support.

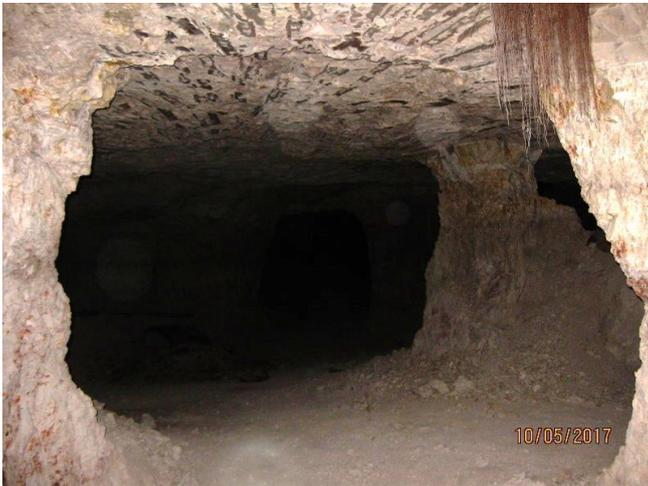
Figure 3: No secondary support.

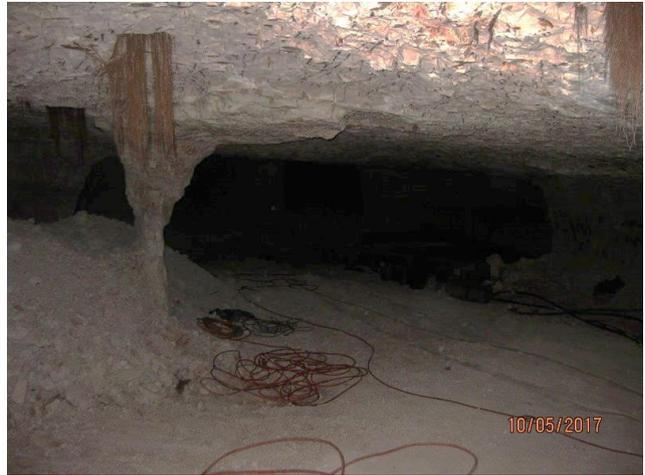
Figure 4: Inadequate secondary. No primary support.

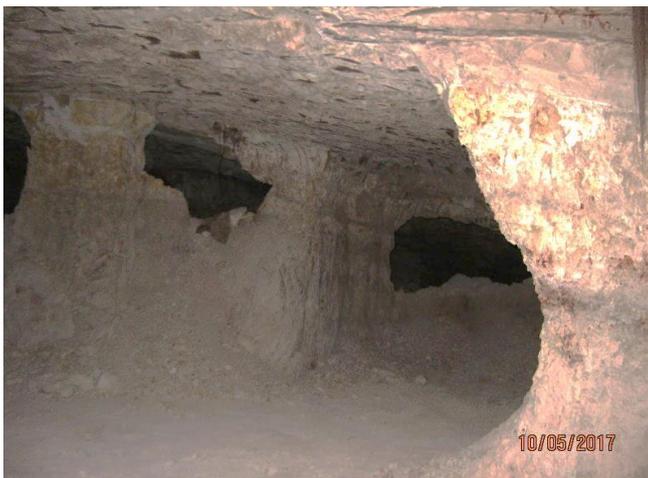
Figure 5: No secondary support installed.

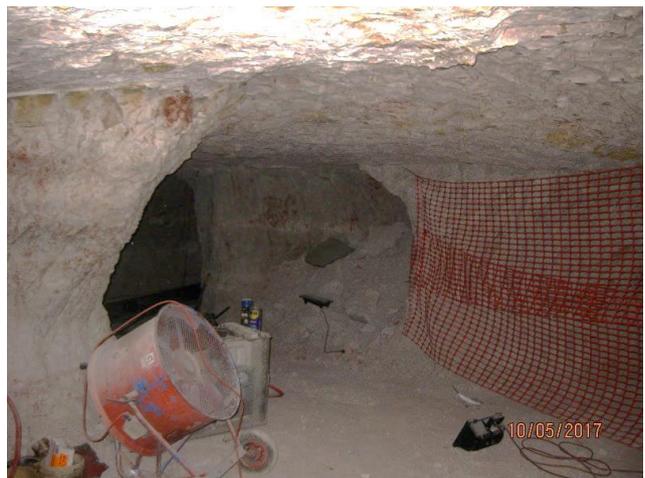
Figure 6: Primary support meshing installed.
