# SAFETY ALERT

## Sudden failure of feed hopper

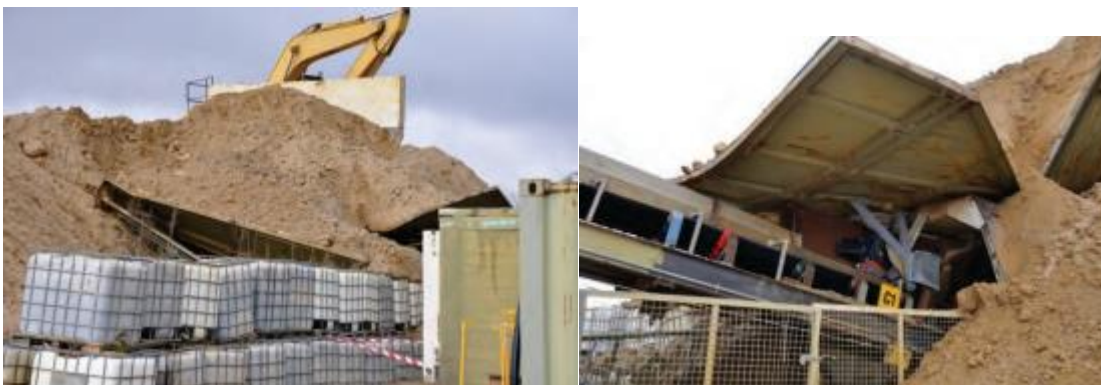
Figures 1 and 2: The ROM feed hopper collapsed onto plant feed conveyor

The feed hopper collapsed unexpectedly onto the feed conveyor, causing substantial damage to plant and structures.

- a) some bolts had pulled through the hopper flange
- b) structural bolt holes that were elongated by a hot torch
- c) missing structural washers on bolts
- d) broken bolts
- e) stripped threads on bolts.

A check of the mine's structural inspection program identified fixed structures at the mine were not being periodically inspected by a suitable competent person.

- a) Mines should have periodic inspections by a competent structural engineer of any structure that may affect the health and safety of people at intervals recommended by the structural engineer. (Refer *Code of practice: Mechanical engineering control plan* clause 4.5.5 '*Inspection and testing of plant*').

If there is no period specified by a structural engineer, inspections should be carried out at two-year intervals.

- b) Steel structures should be designed, fabricated and erected in accordance with *AS 4100 - Steel structures* or *AS 3990 - Mechanical equipment – Steelwork* and other relevant Australian Standards where applicable.
- c) Fixed bulk material belt conveyors (including their structures) should be designed, installed and maintained in accordance with –
  - *AS/NZS 4024.3610 Safety of machinery - Conveyors - General requirements*
  - *AS/NZS 4024.3611 Safety of machinery - Conveyors - Belt conveyors for bulk materials handling*
- d) Holes in fabrications for structural connections should not be elongated with a hot torch. Structural washers should always be used along with correct pre-tensioning.
